Pentium® II Xeon™ Processor Specification Update

Release Date: November 1999

Order Number: 243776-017

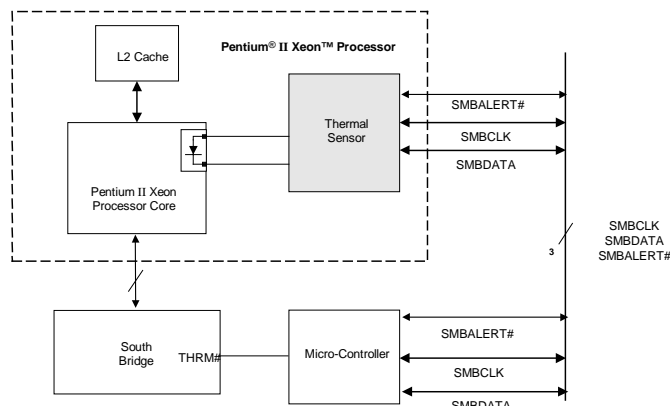
Figure 1. An Example of Microcontroller Driven Thermal Management

Problem: The Pentium II Xeon processor has a thermal sensor that monitors the processor core's temperature. The thermal sensor asserts SMBALERT# if the processor temperature exceeds the temperature limits set in the Alarm Threshold Registers (T_{HIGH} , T_{LOW}). It also sets the corresponding Status Register bits to identify the cause of the interrupt. Figure 1 gives one example of the how the SMBALERT# signal could be used in a system.

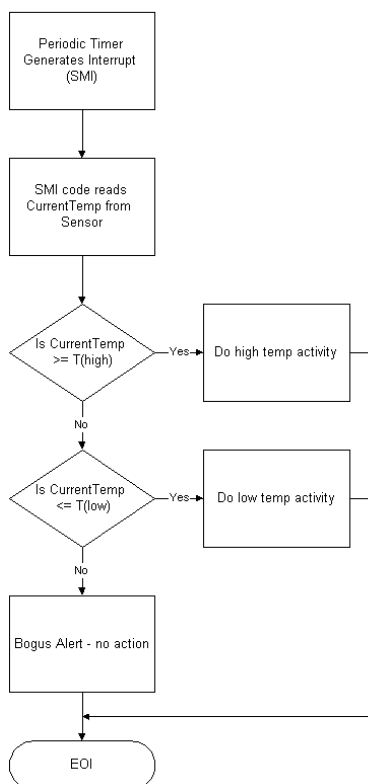
Figure 3. Workaround Flowchart: SMI#-Driven System

1. Before servicing an interrupt from the thermal sensor, read and compare the processor thermal reading with the threshold limits (T_{HIGH} or T_{LOW}). Figures 2 and 3 provide basic flowcharts for the implementation of this workaround in an interrupt driven system.
2. If the firmware implemented polls the Status Register only, then before taking any action, re-read the temperature register and do a comparison with the alarm threshold limits (T_{HIGH} or T_{LOW}) to determine if the value is actually still within the temperature window.
3. Use a temperature polling scheme to monitor the processor temperature
